## 10 DEVELOPMENT AND INFRASTRUCTURE

### 10.1 PROPOSED PLANNING SCHEME AMENDMENT C154 - 15-35 EAST STREET KILMORE

## Seymour Heritage Bridge - Stage 2

## Heritage Bridge Over the Goulburn River, at Seymour OPTION ASSESSMENT REPORT

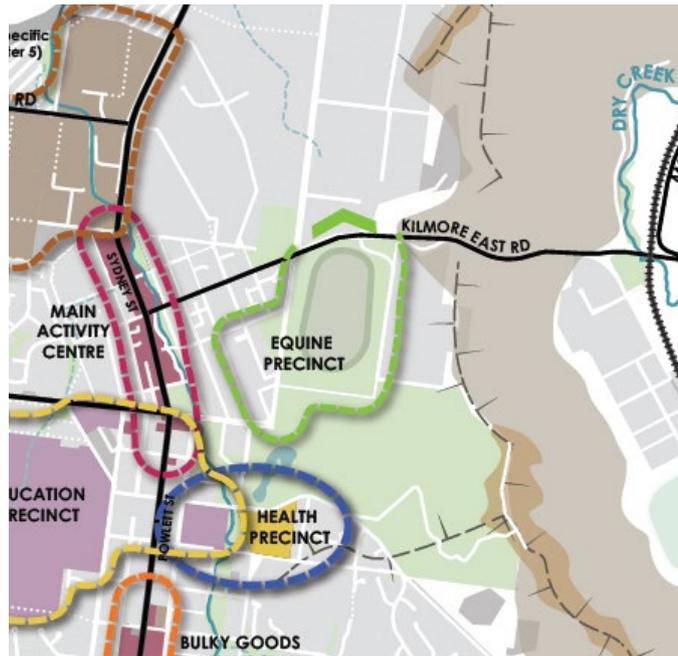
Figure 2 – Excerpt of Figure 43 from Kilmore Stucutre Plan showing growth of Equine Precinct to the north.

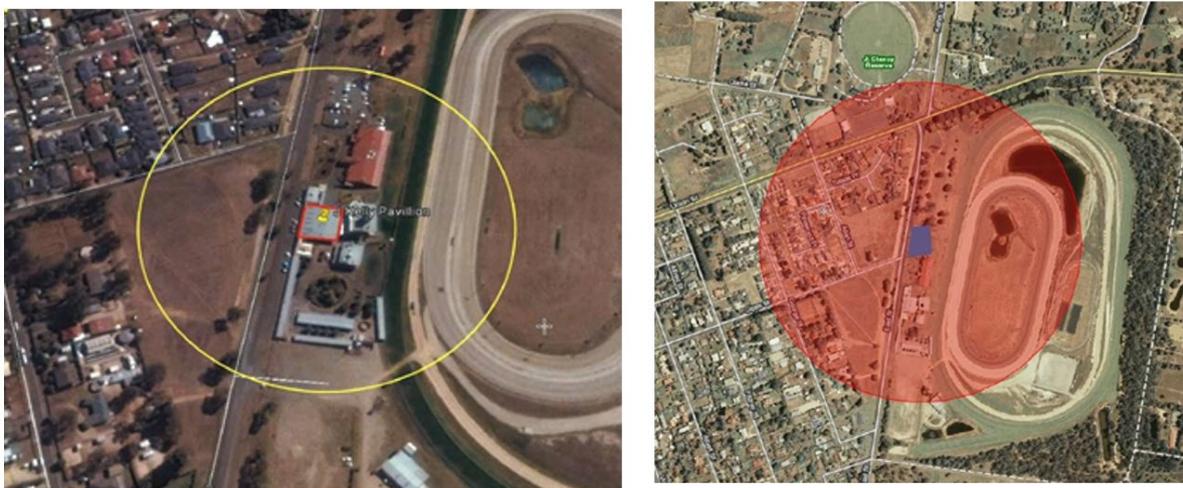
Figure 3 – Excerpt from Deed of Consent for Non Council-Owned Land – Kilmore Racecourse and Recreation Reserve J Kelly Pavilion and Carpark.

- Certificate of Title Vol 1989 Fol 650, at Crown Allotment 13M1 Parish of Glenburnie,
- Specifically, the premises of the J Kelly Pavilion (betting area) and carpark on the Land, as shown in Figure 3.

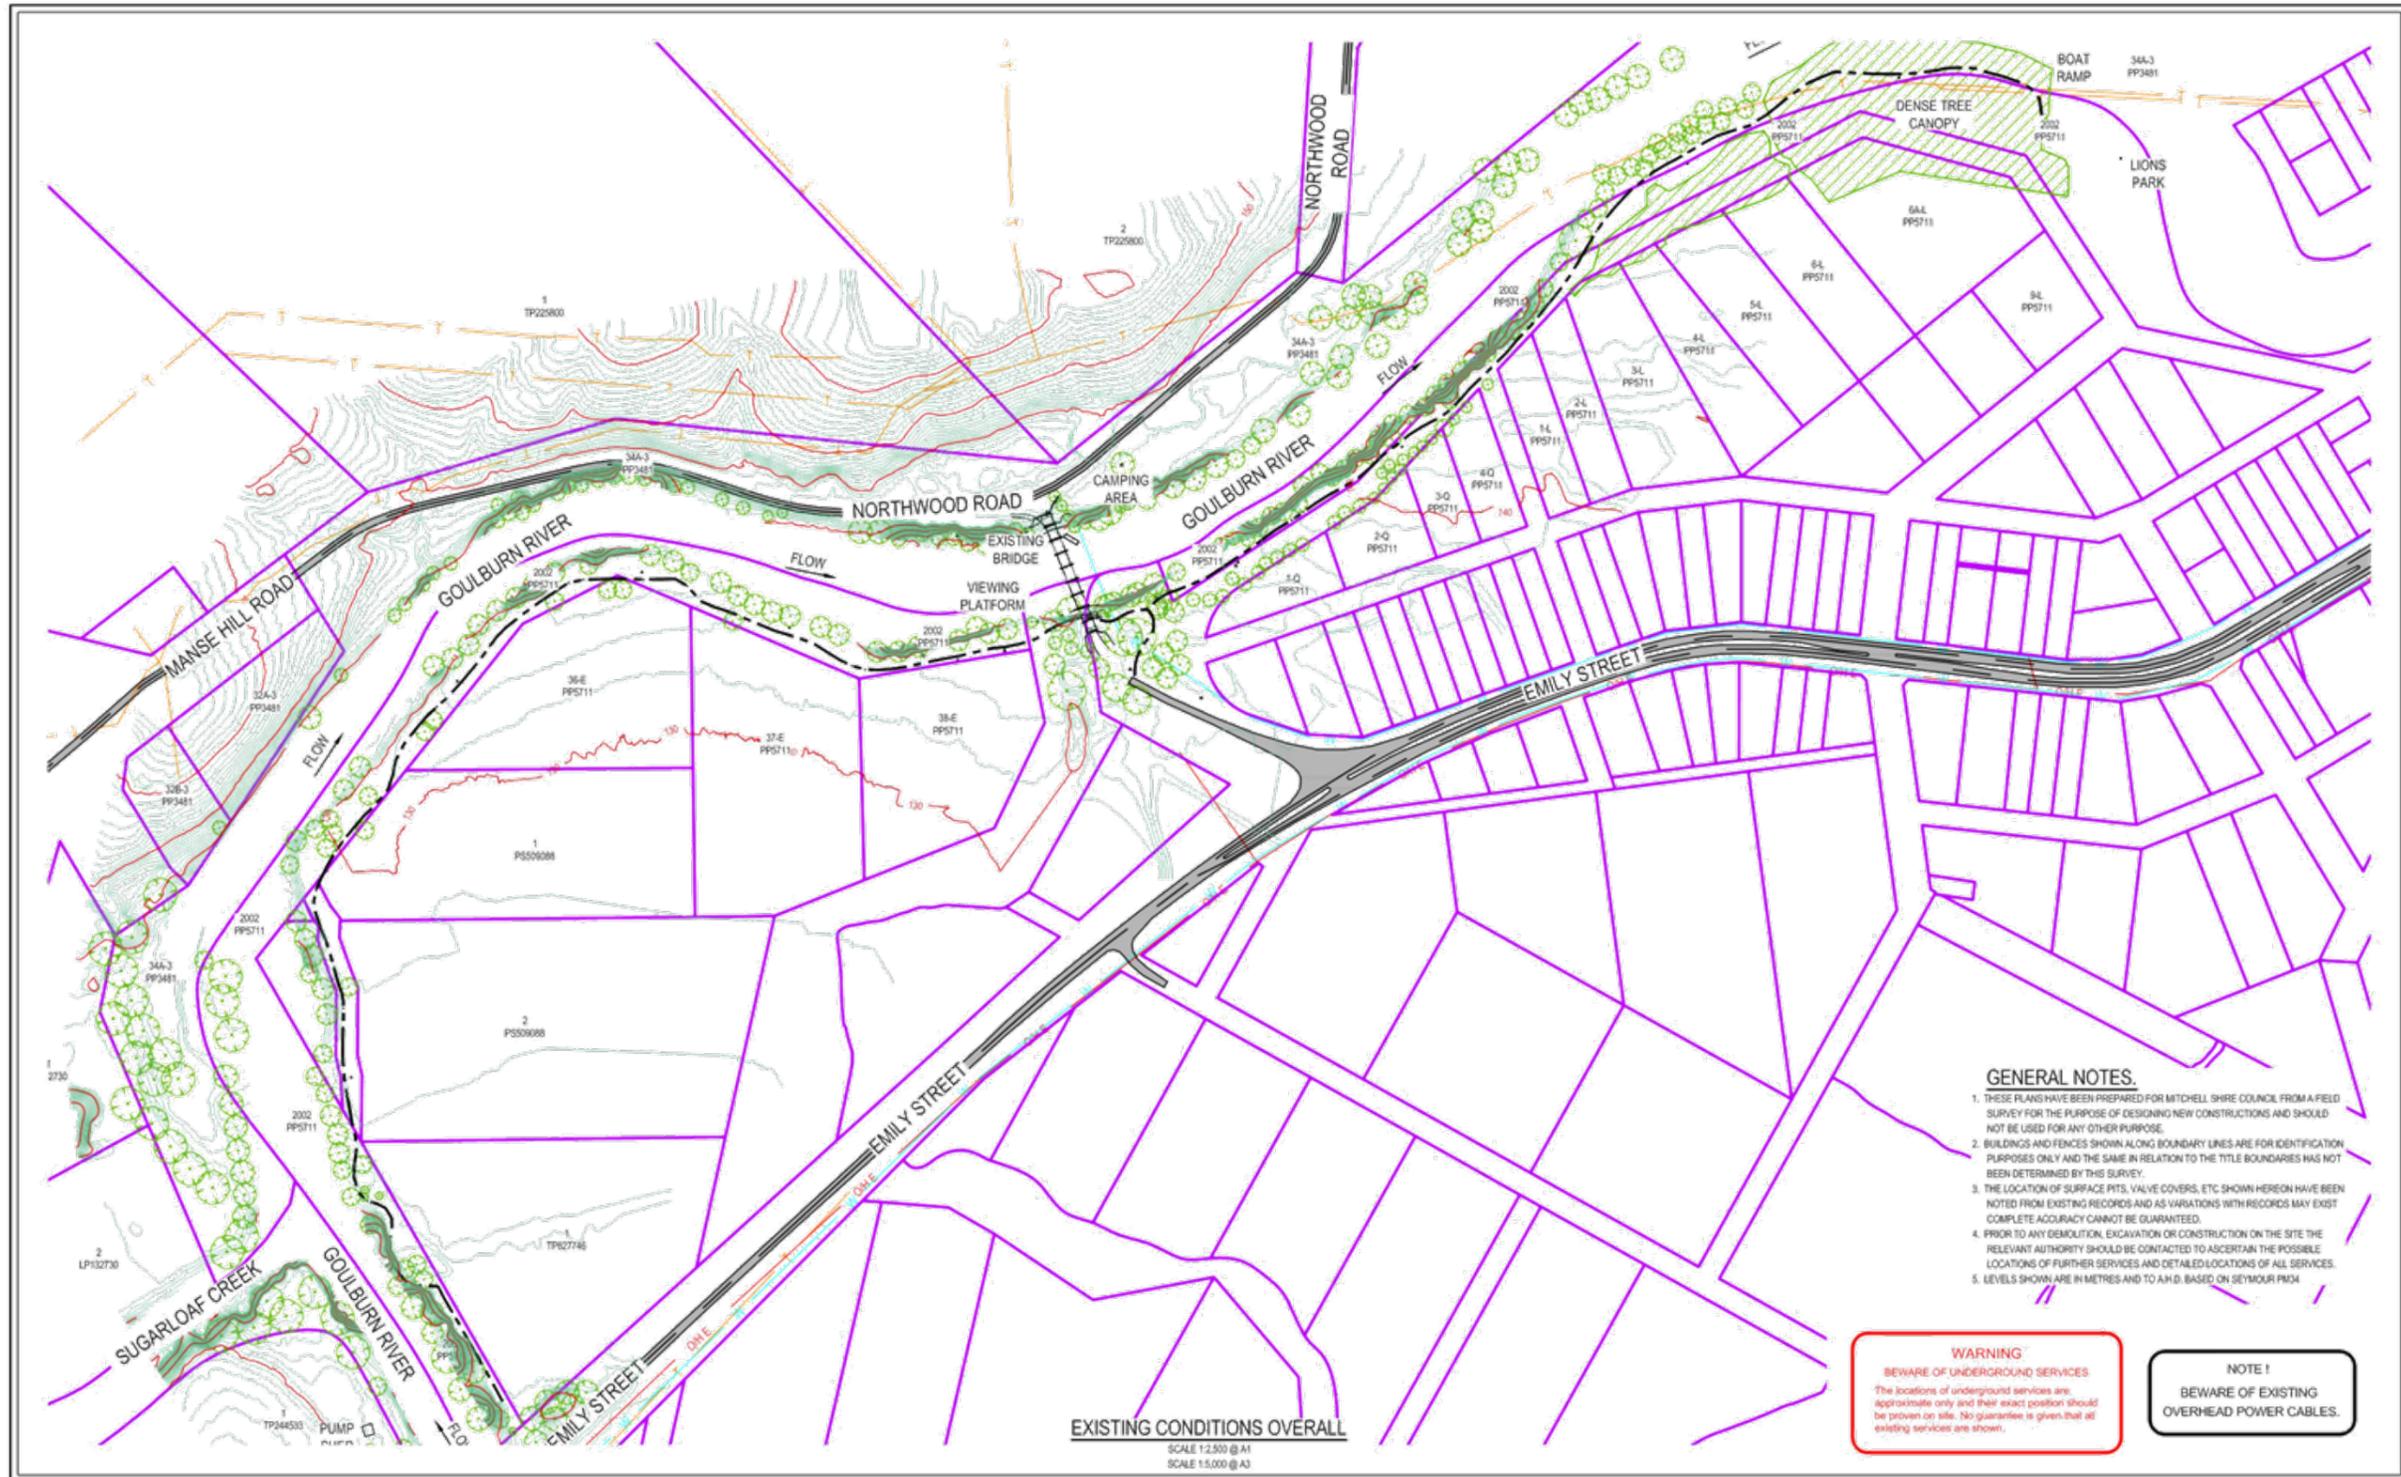
Existing Conditions - Aerial Overall  
Drawing No. GMR07048.09.02  
Revision: A Sheet No. 02  
GMR07048.09.02 Existing Conditions.dwg

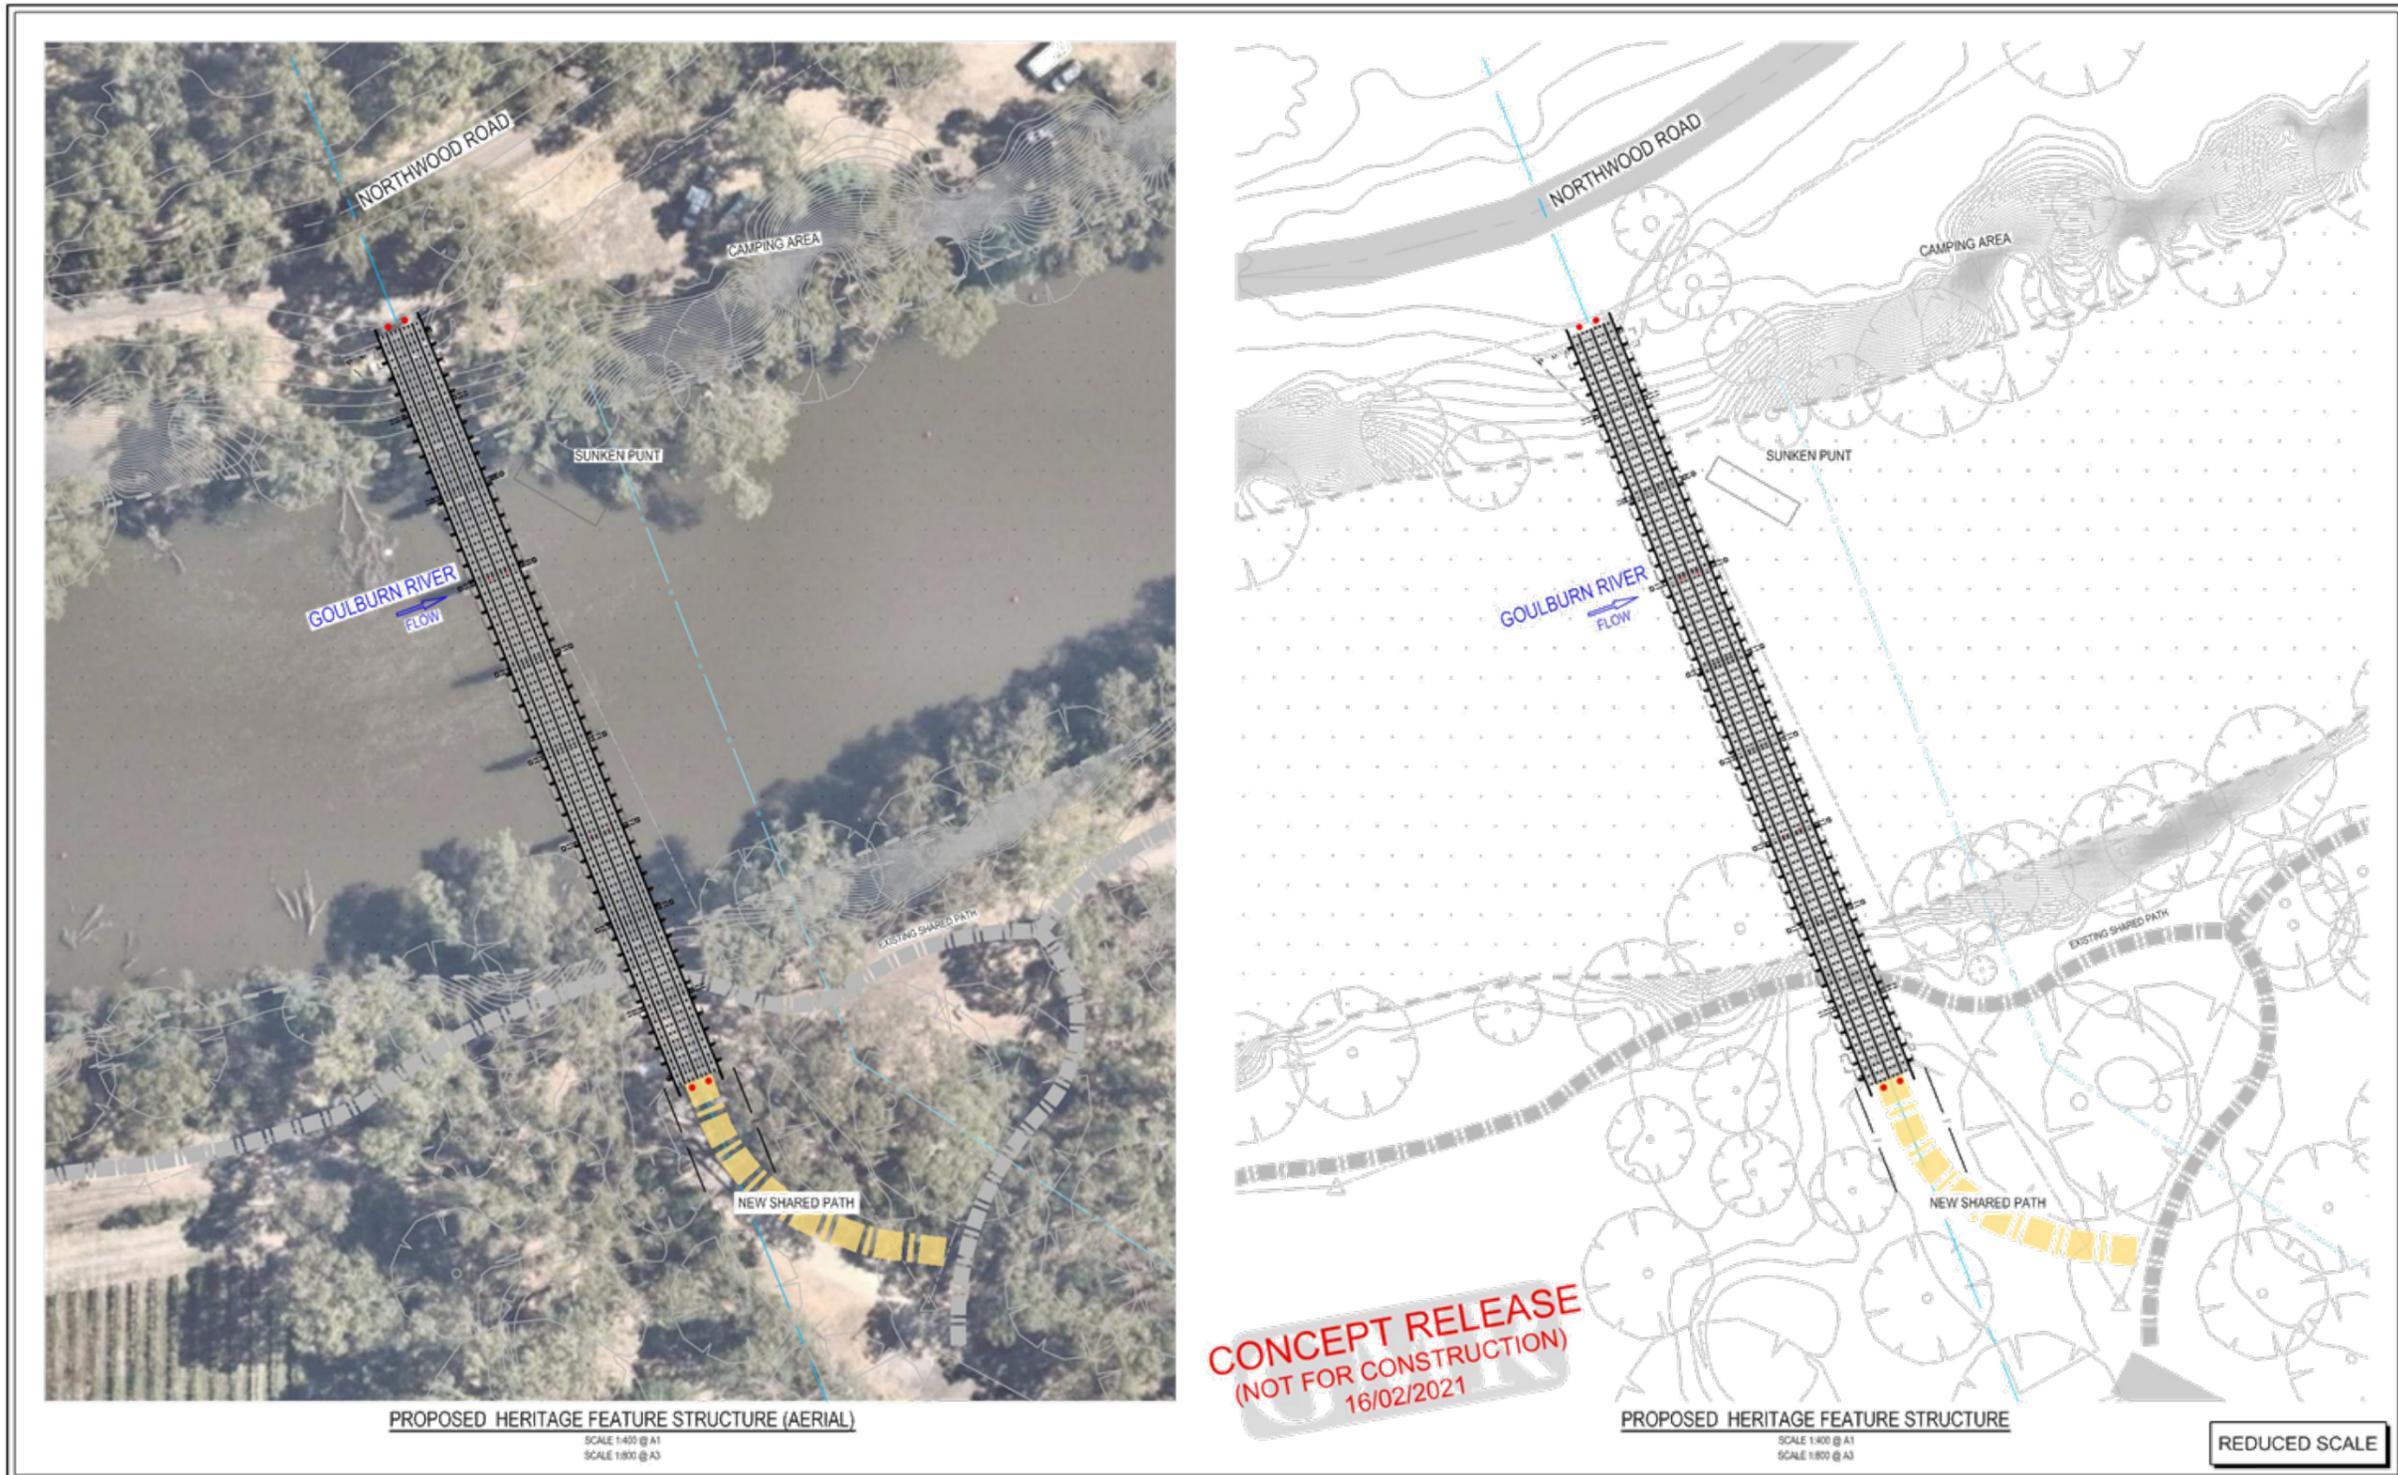
Existing Conditions Overall  
Drawing No. GMR07048.09.03  
Revision: A Sheet No. 03  
GMR07048.09.02 Existing Conditions.dwg

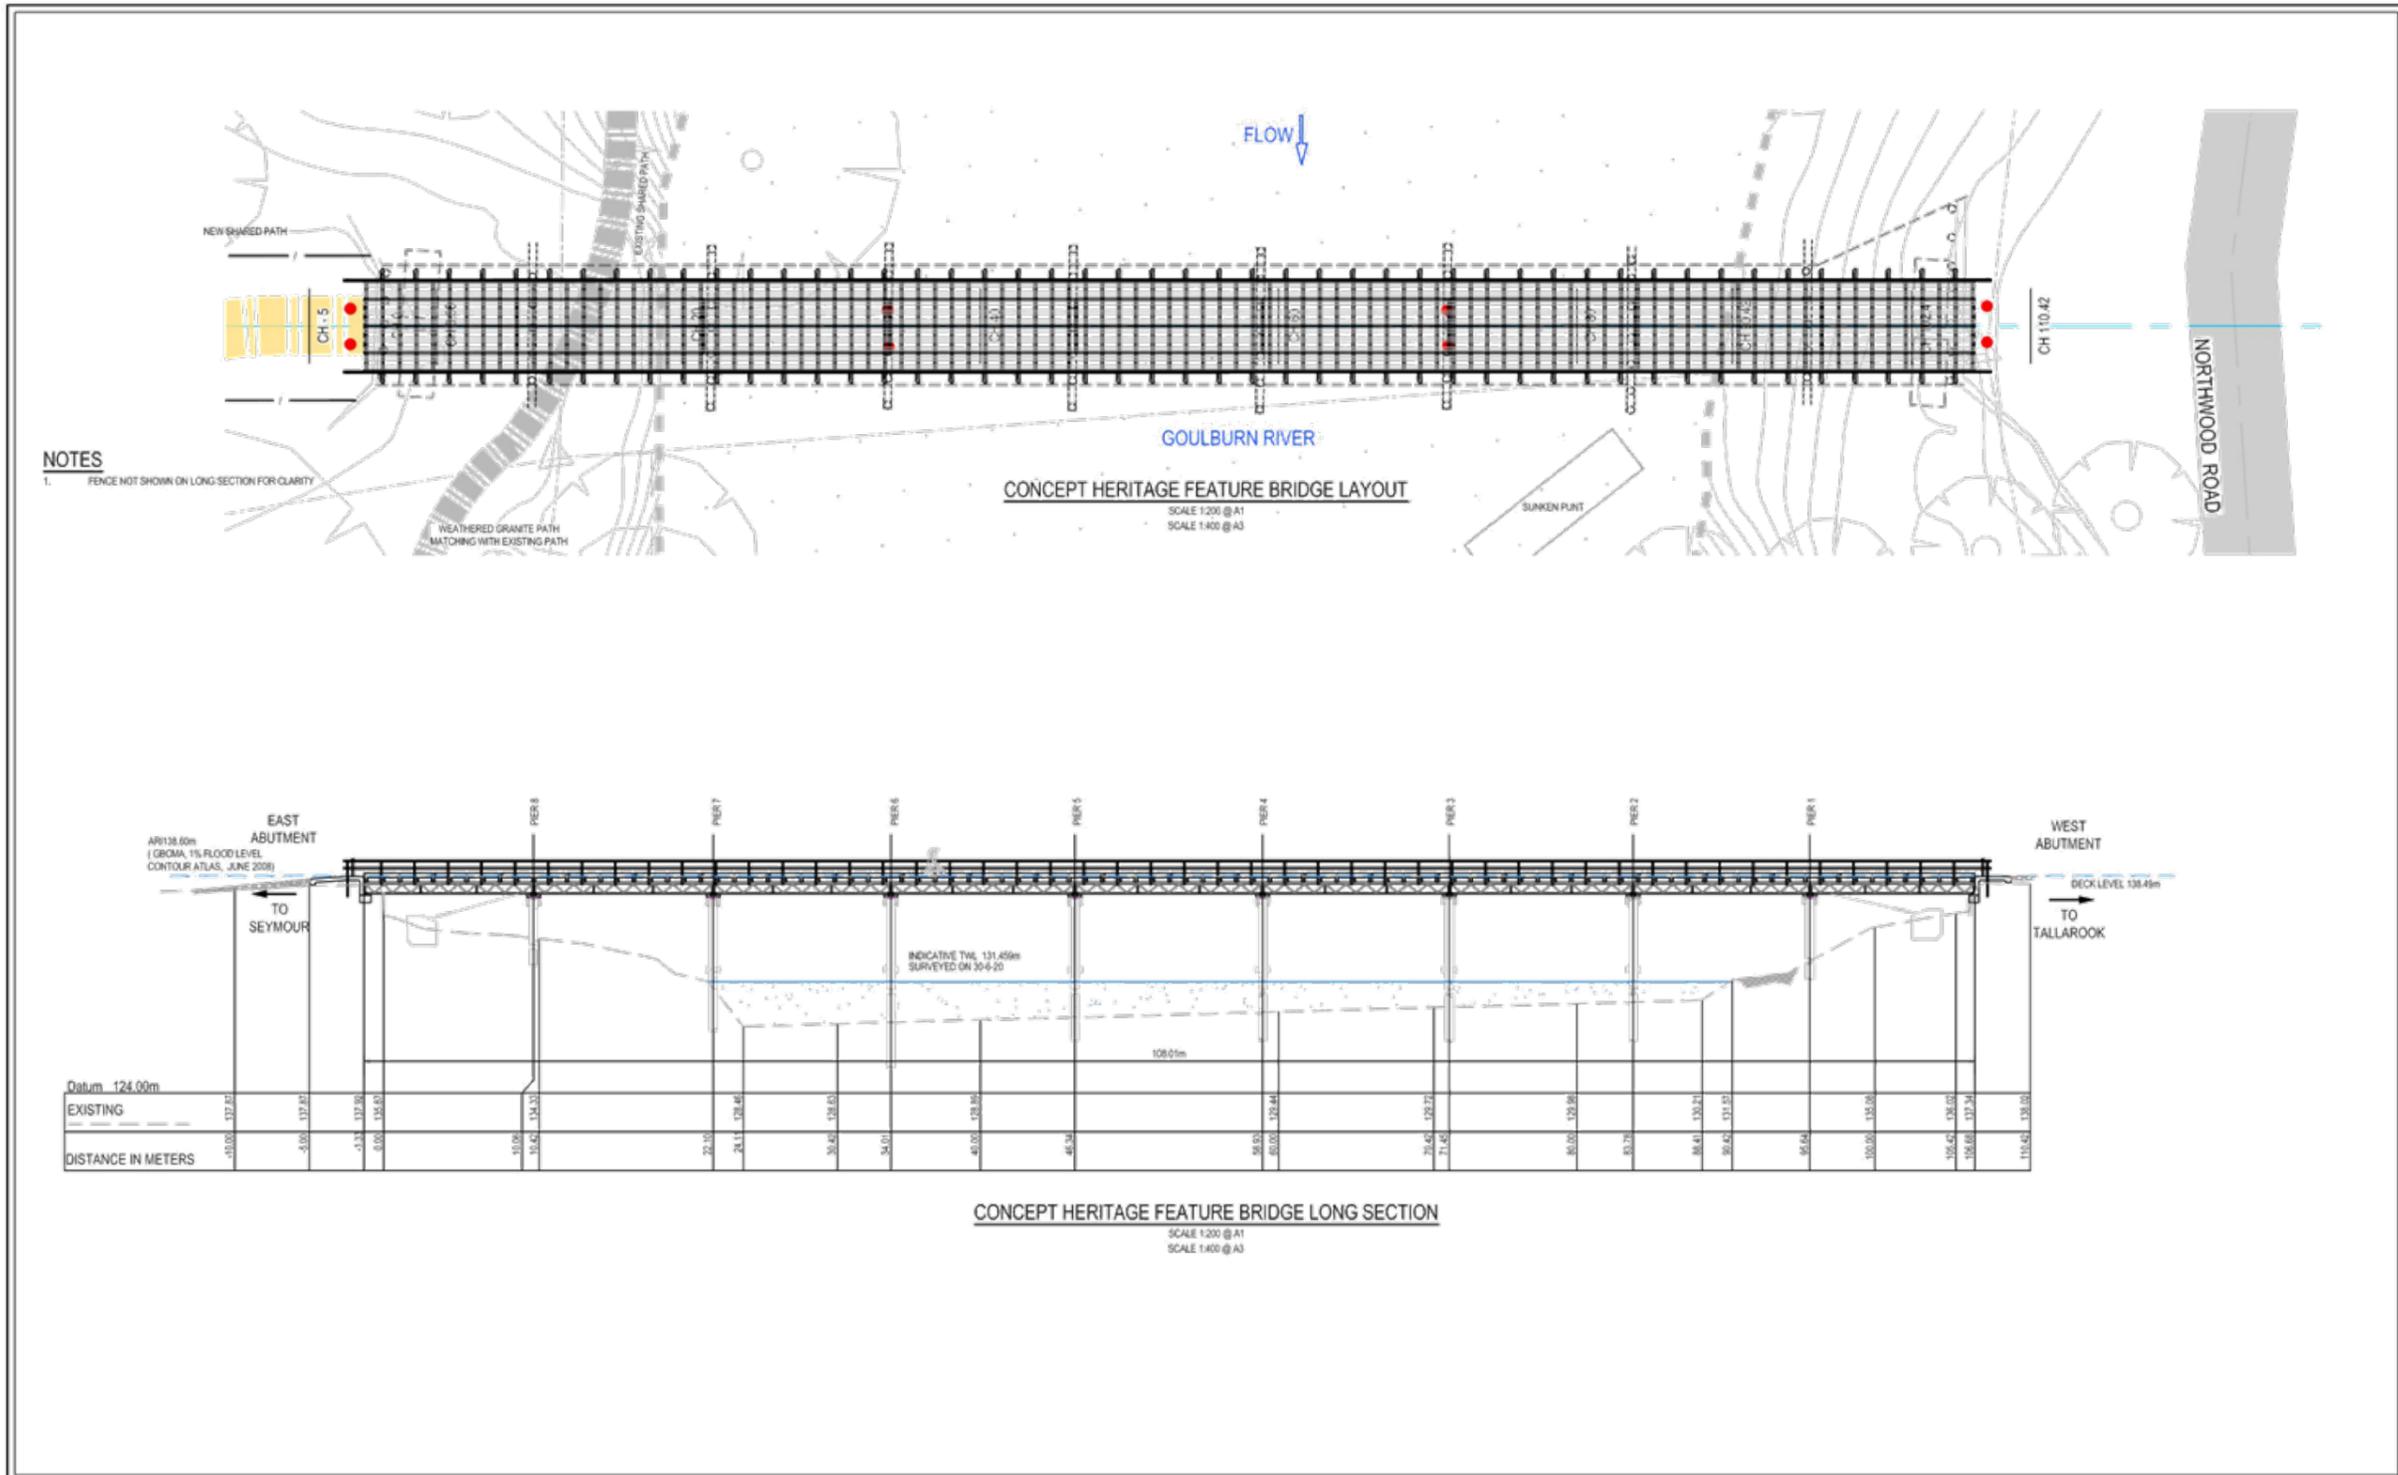
**GMR Engineering Services**  
**Mitchell Shire Council**  
 Seymour Heritage Bridge - Stage 2  
 Goulburn River, Seymour  
 Option A  
 Heritage Feature Structure Site Plan  
 Drawing No. GMR07048-9.04  
 Revision: B Sheet No. 04  
 GMR07048.09.13 Existing Bridge Concept 2.dwg

**CONCEPT HERITAGE FEATURE BRIDGE LAYOUT**  
 SCALE 1:200 @ A1  
 SCALE 1:400 @ A3

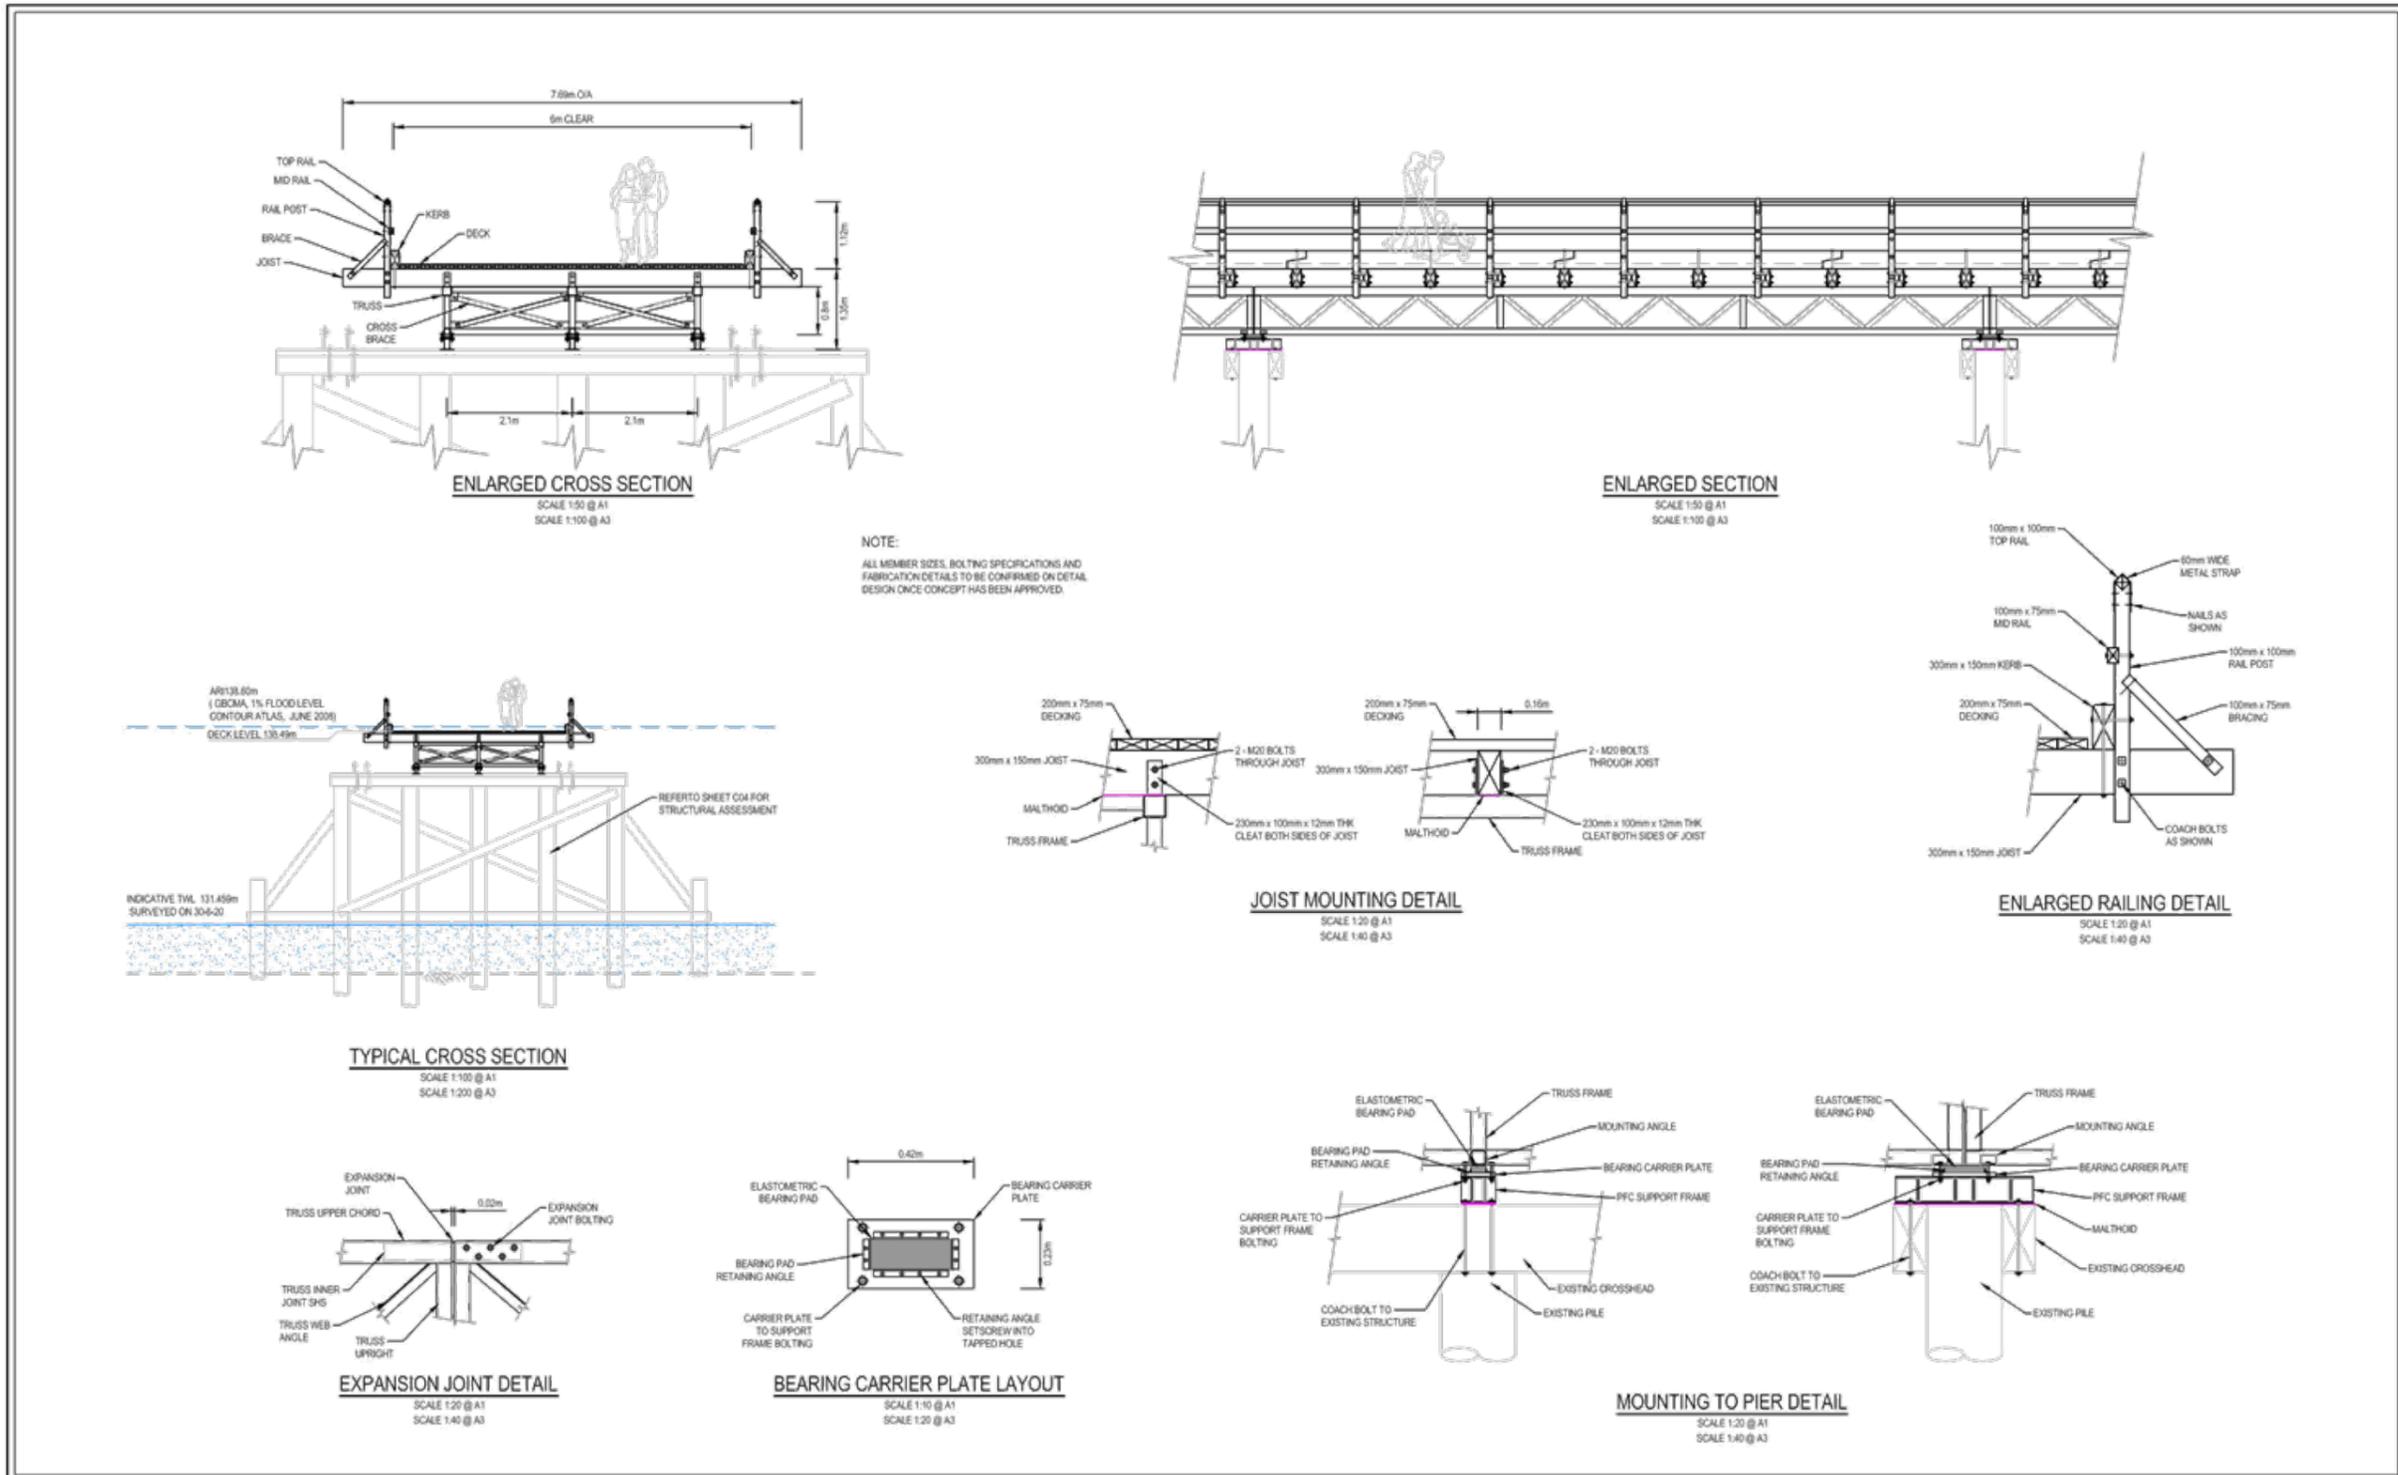
**GMR Engineering Services**  
**Mitchell Shire Council**  
 Seymour Heritage Bridge - Stage 2  
 Goulburn River, Seymour  
 Option A  
 Heritage Feature Structure Layout  
 Drawing No. GMR07048-9.05  
 Revision: B Sheet No. 05  
 GMR07048.09.13 Existing Bridge Concept 2.dwg

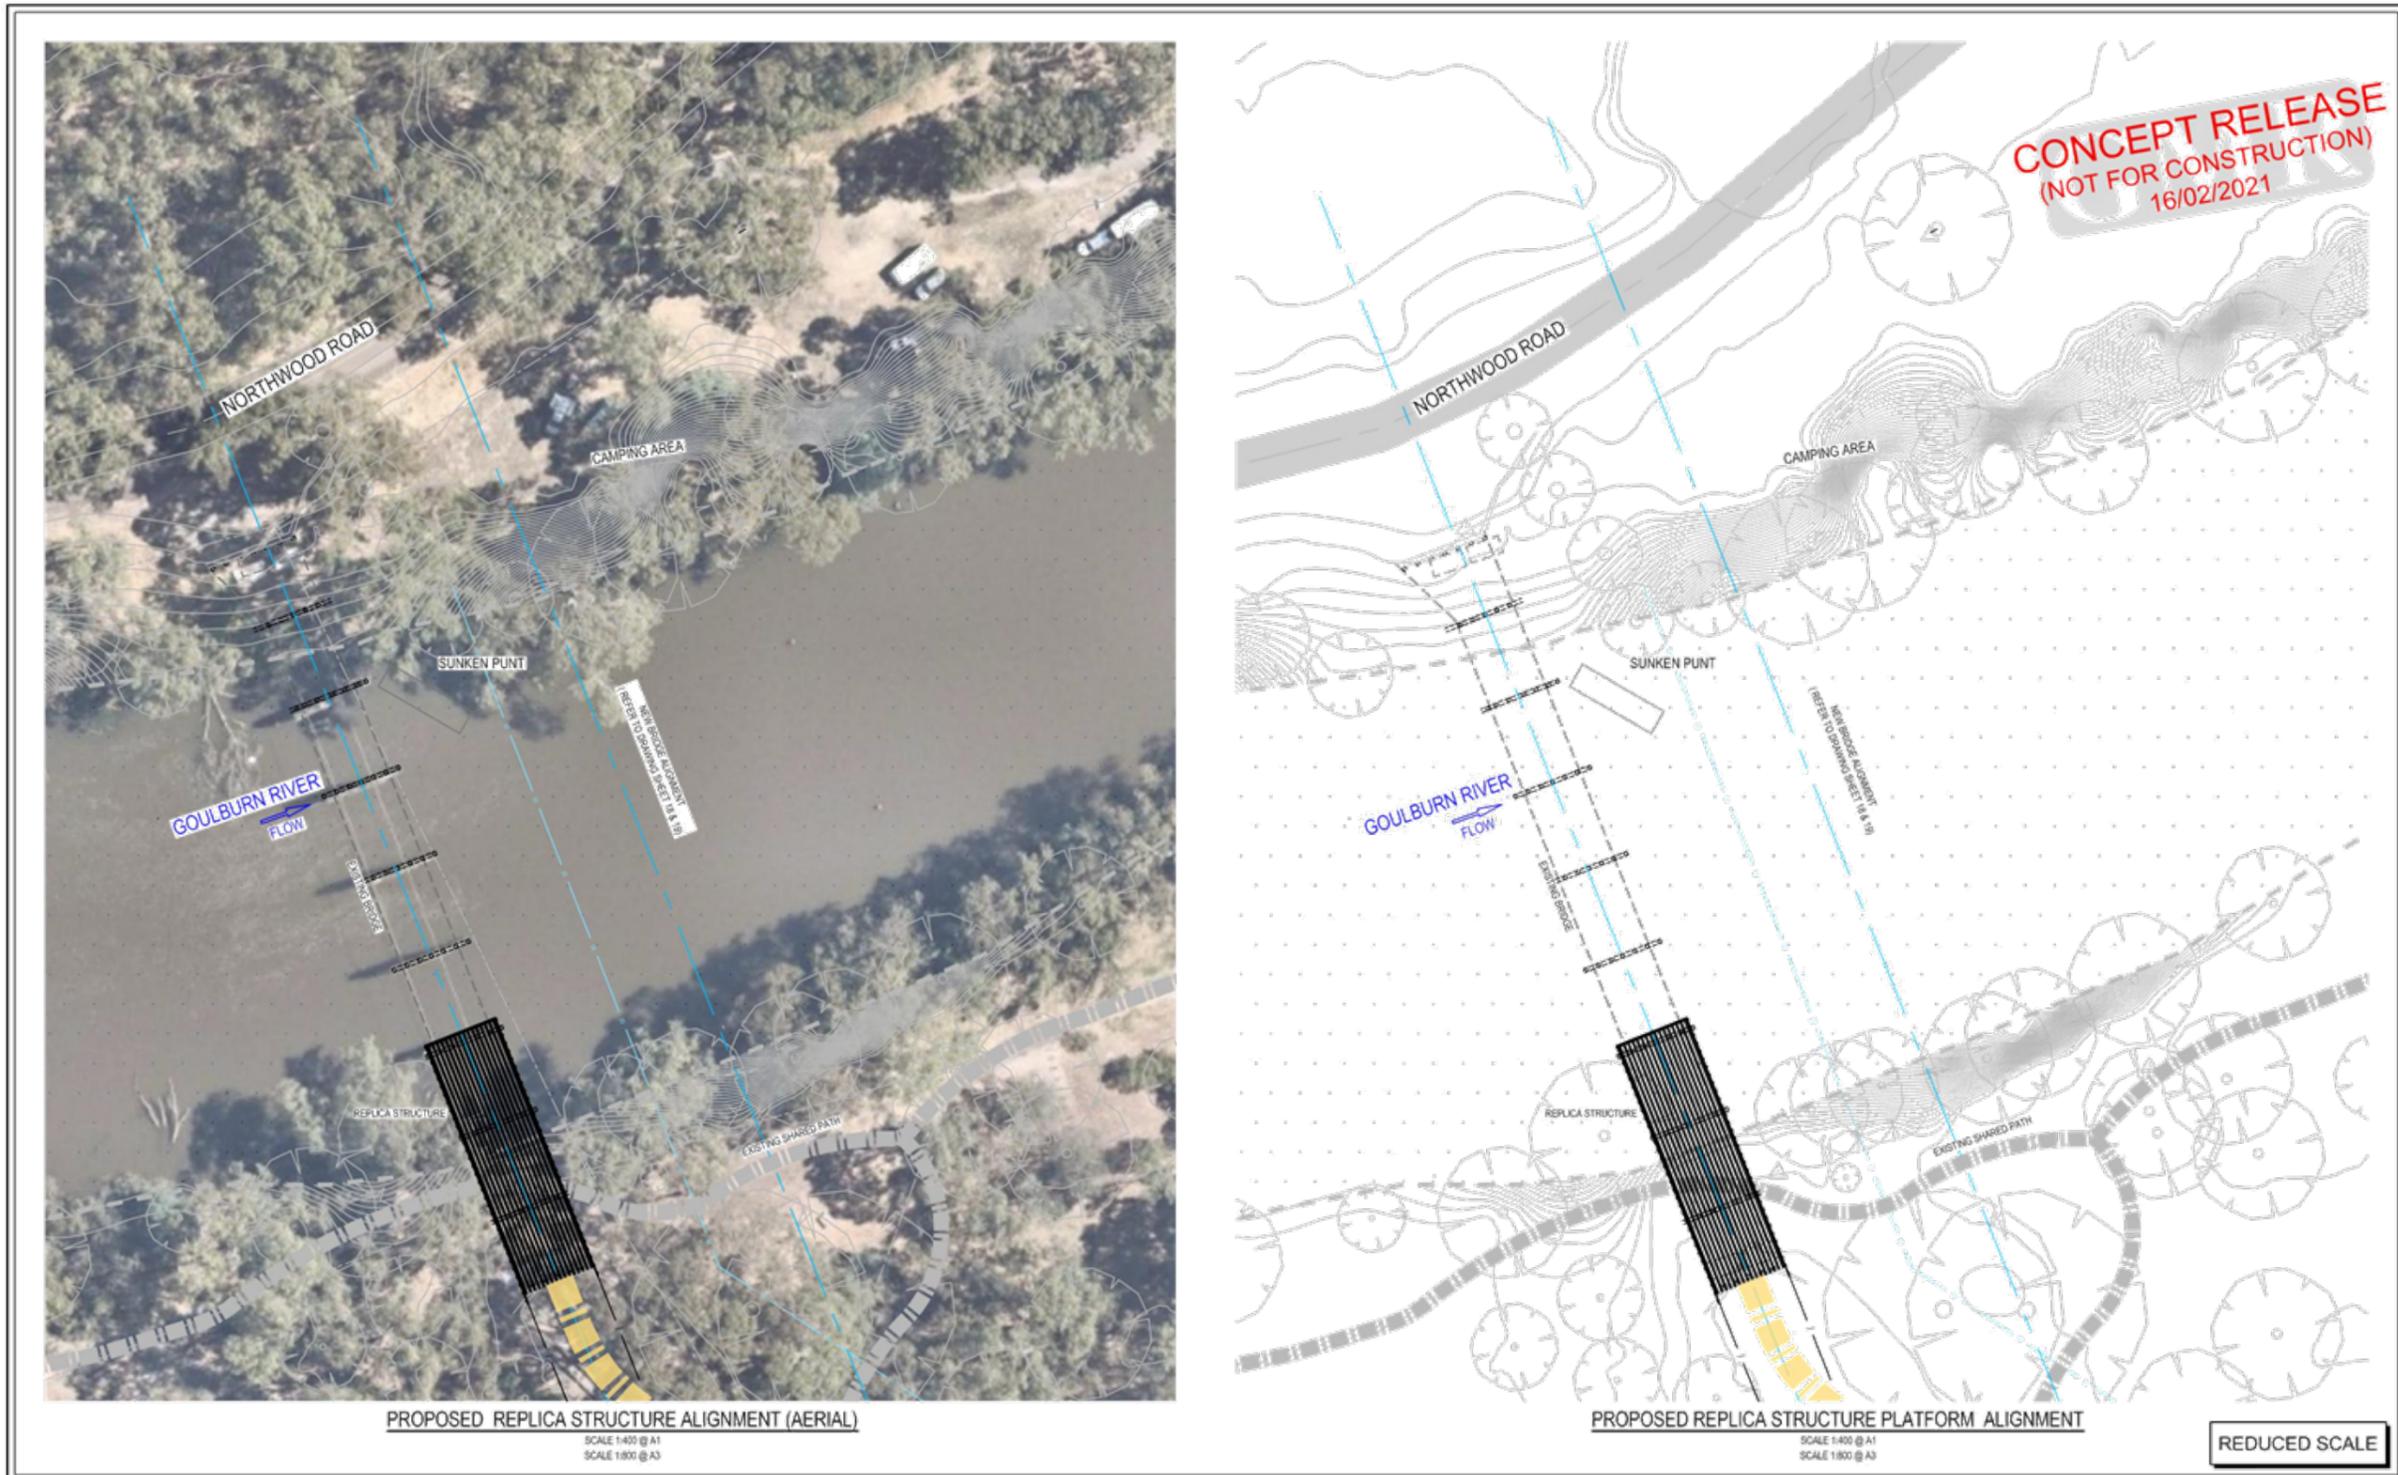
**GMR Engineering Services**  
**Mitchell Shire Council**  
**Seymour Heritage Bridge - Stage 2**  
Goulburn River, Seymour  
Option A  
Heritage Feature Details  
Drawing No. GMR07048-9.06  
Revision: B Sheet No. 06  
GMR07048.09.13 Existing Bridge Concept 2.dwg A1

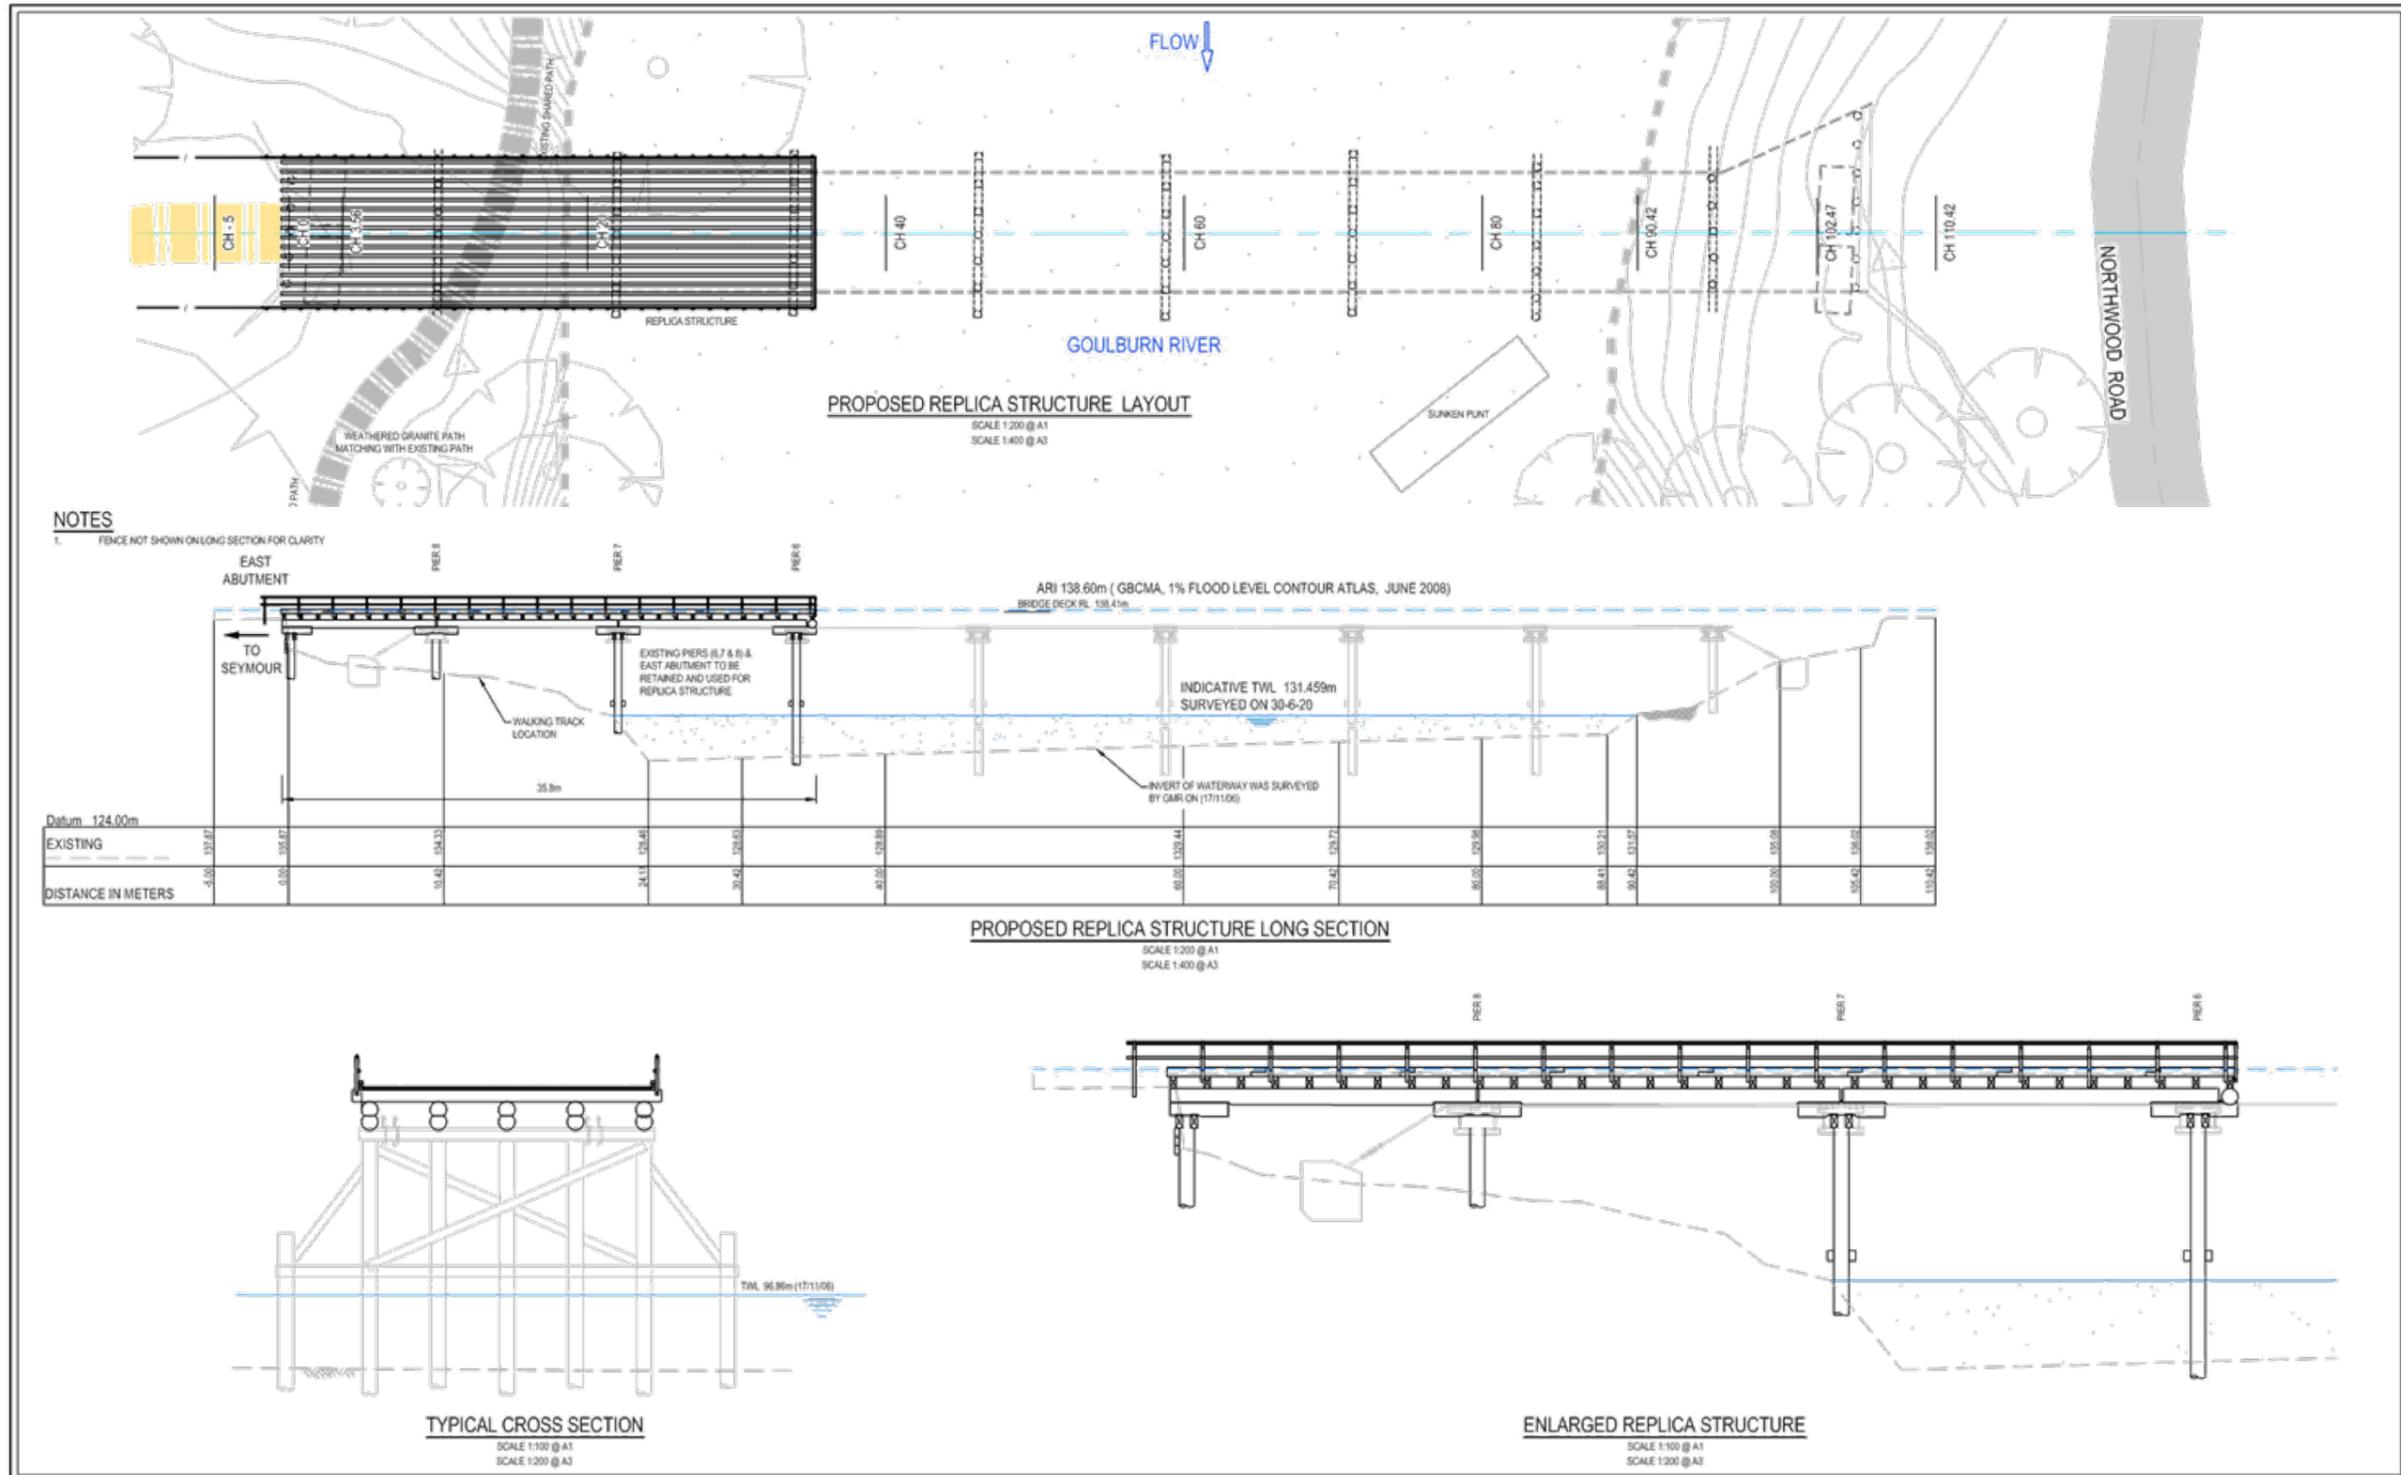
**GMR Engineering Services**  
**Mitchell Shire Council**  
**Seymour Heritage Bridge - Stage 2**  
 Goulburn River, Seymour  
 Option B  
 Partial Reconstruction "Replica" Site Plan  
 Drawing No. GMR07048-9.07  
 Revision: A Sheet No. 07  
 GMR07048.09.05 Replica Structure.dwg
