## 10 DEVELOPMENT AND INFRASTRUCTURE

### 10.1 PROPOSED PLANNING SCHEME AMENDMENT C154 - 15-35 EAST STREET KILMORE

## Seymour Heritage Bridge - Stage 2

## Heritage Bridge Over the Goulburn River, at Seymour OPTION ASSESSMENT REPORT

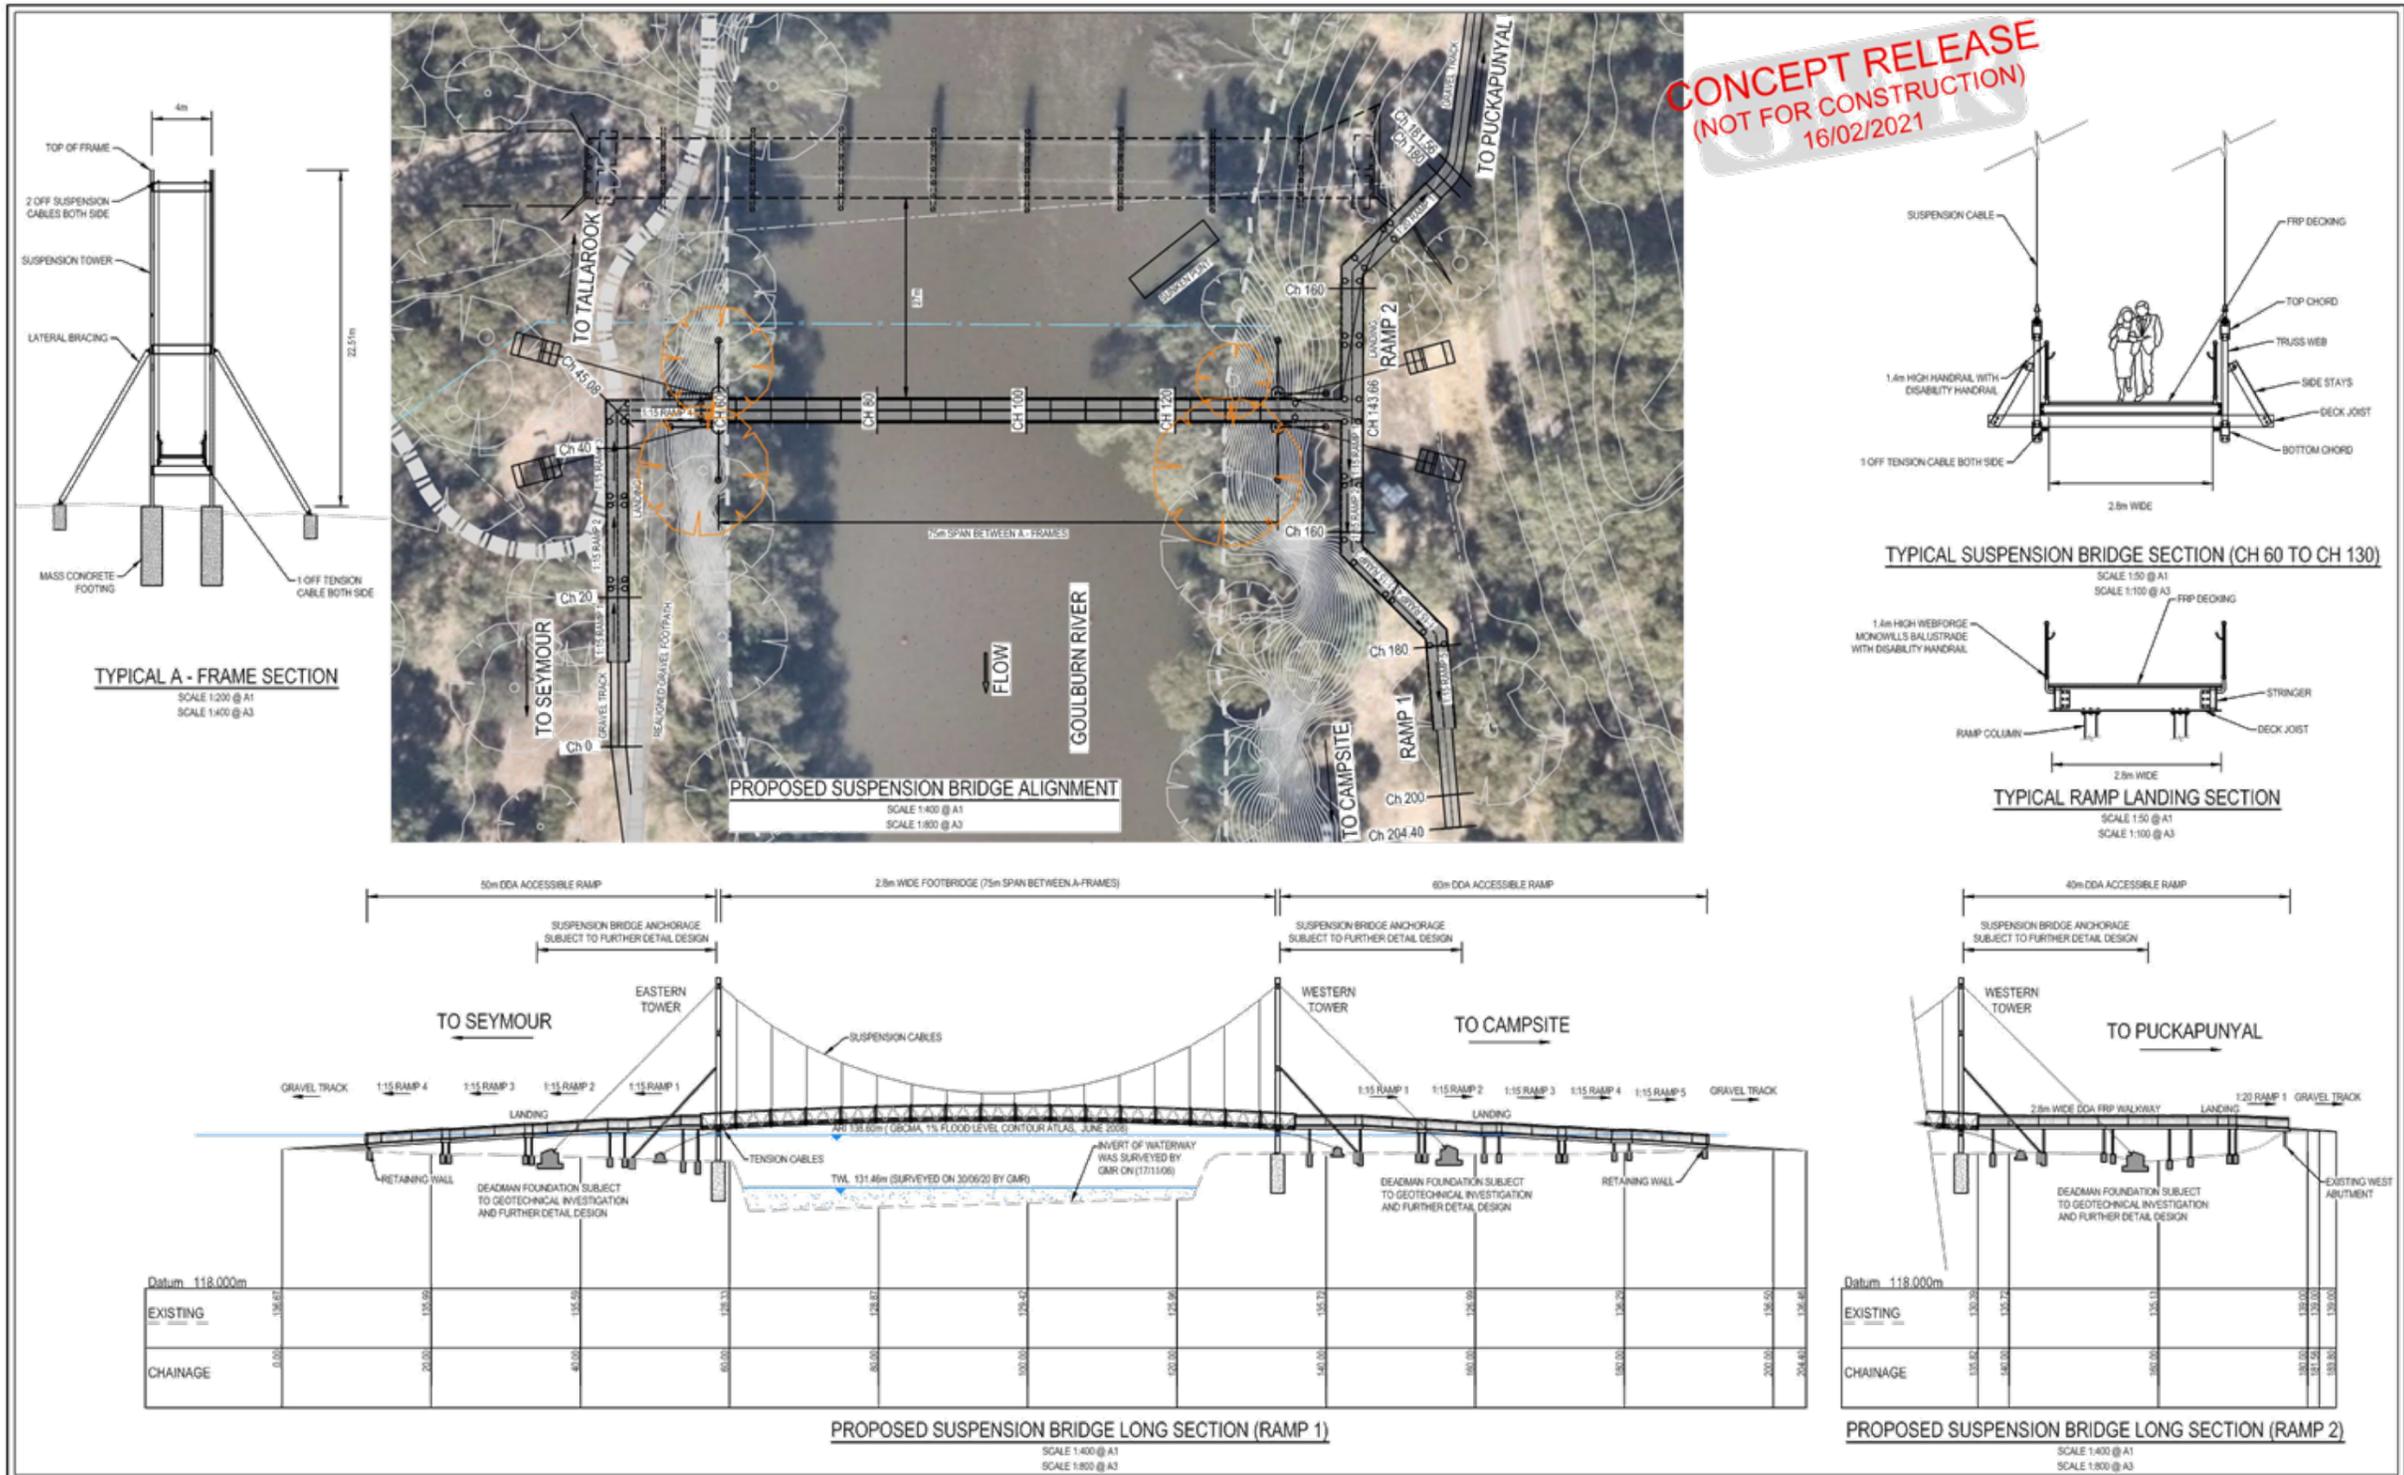
**GMR Engineering Services**  
**Mitchell Shire Council**  
**Seymour Heritage Bridge - Stage 2**  
 Goulburn River, Seymour  
 Option C  
 New Standalone Footbridge Site Plan  
 Drawing No. GMR07048-9.09  
 Revision: A  
 Sheet No. 09  
 GMR07048.09.07 Suspension Bridge Structure.dwg

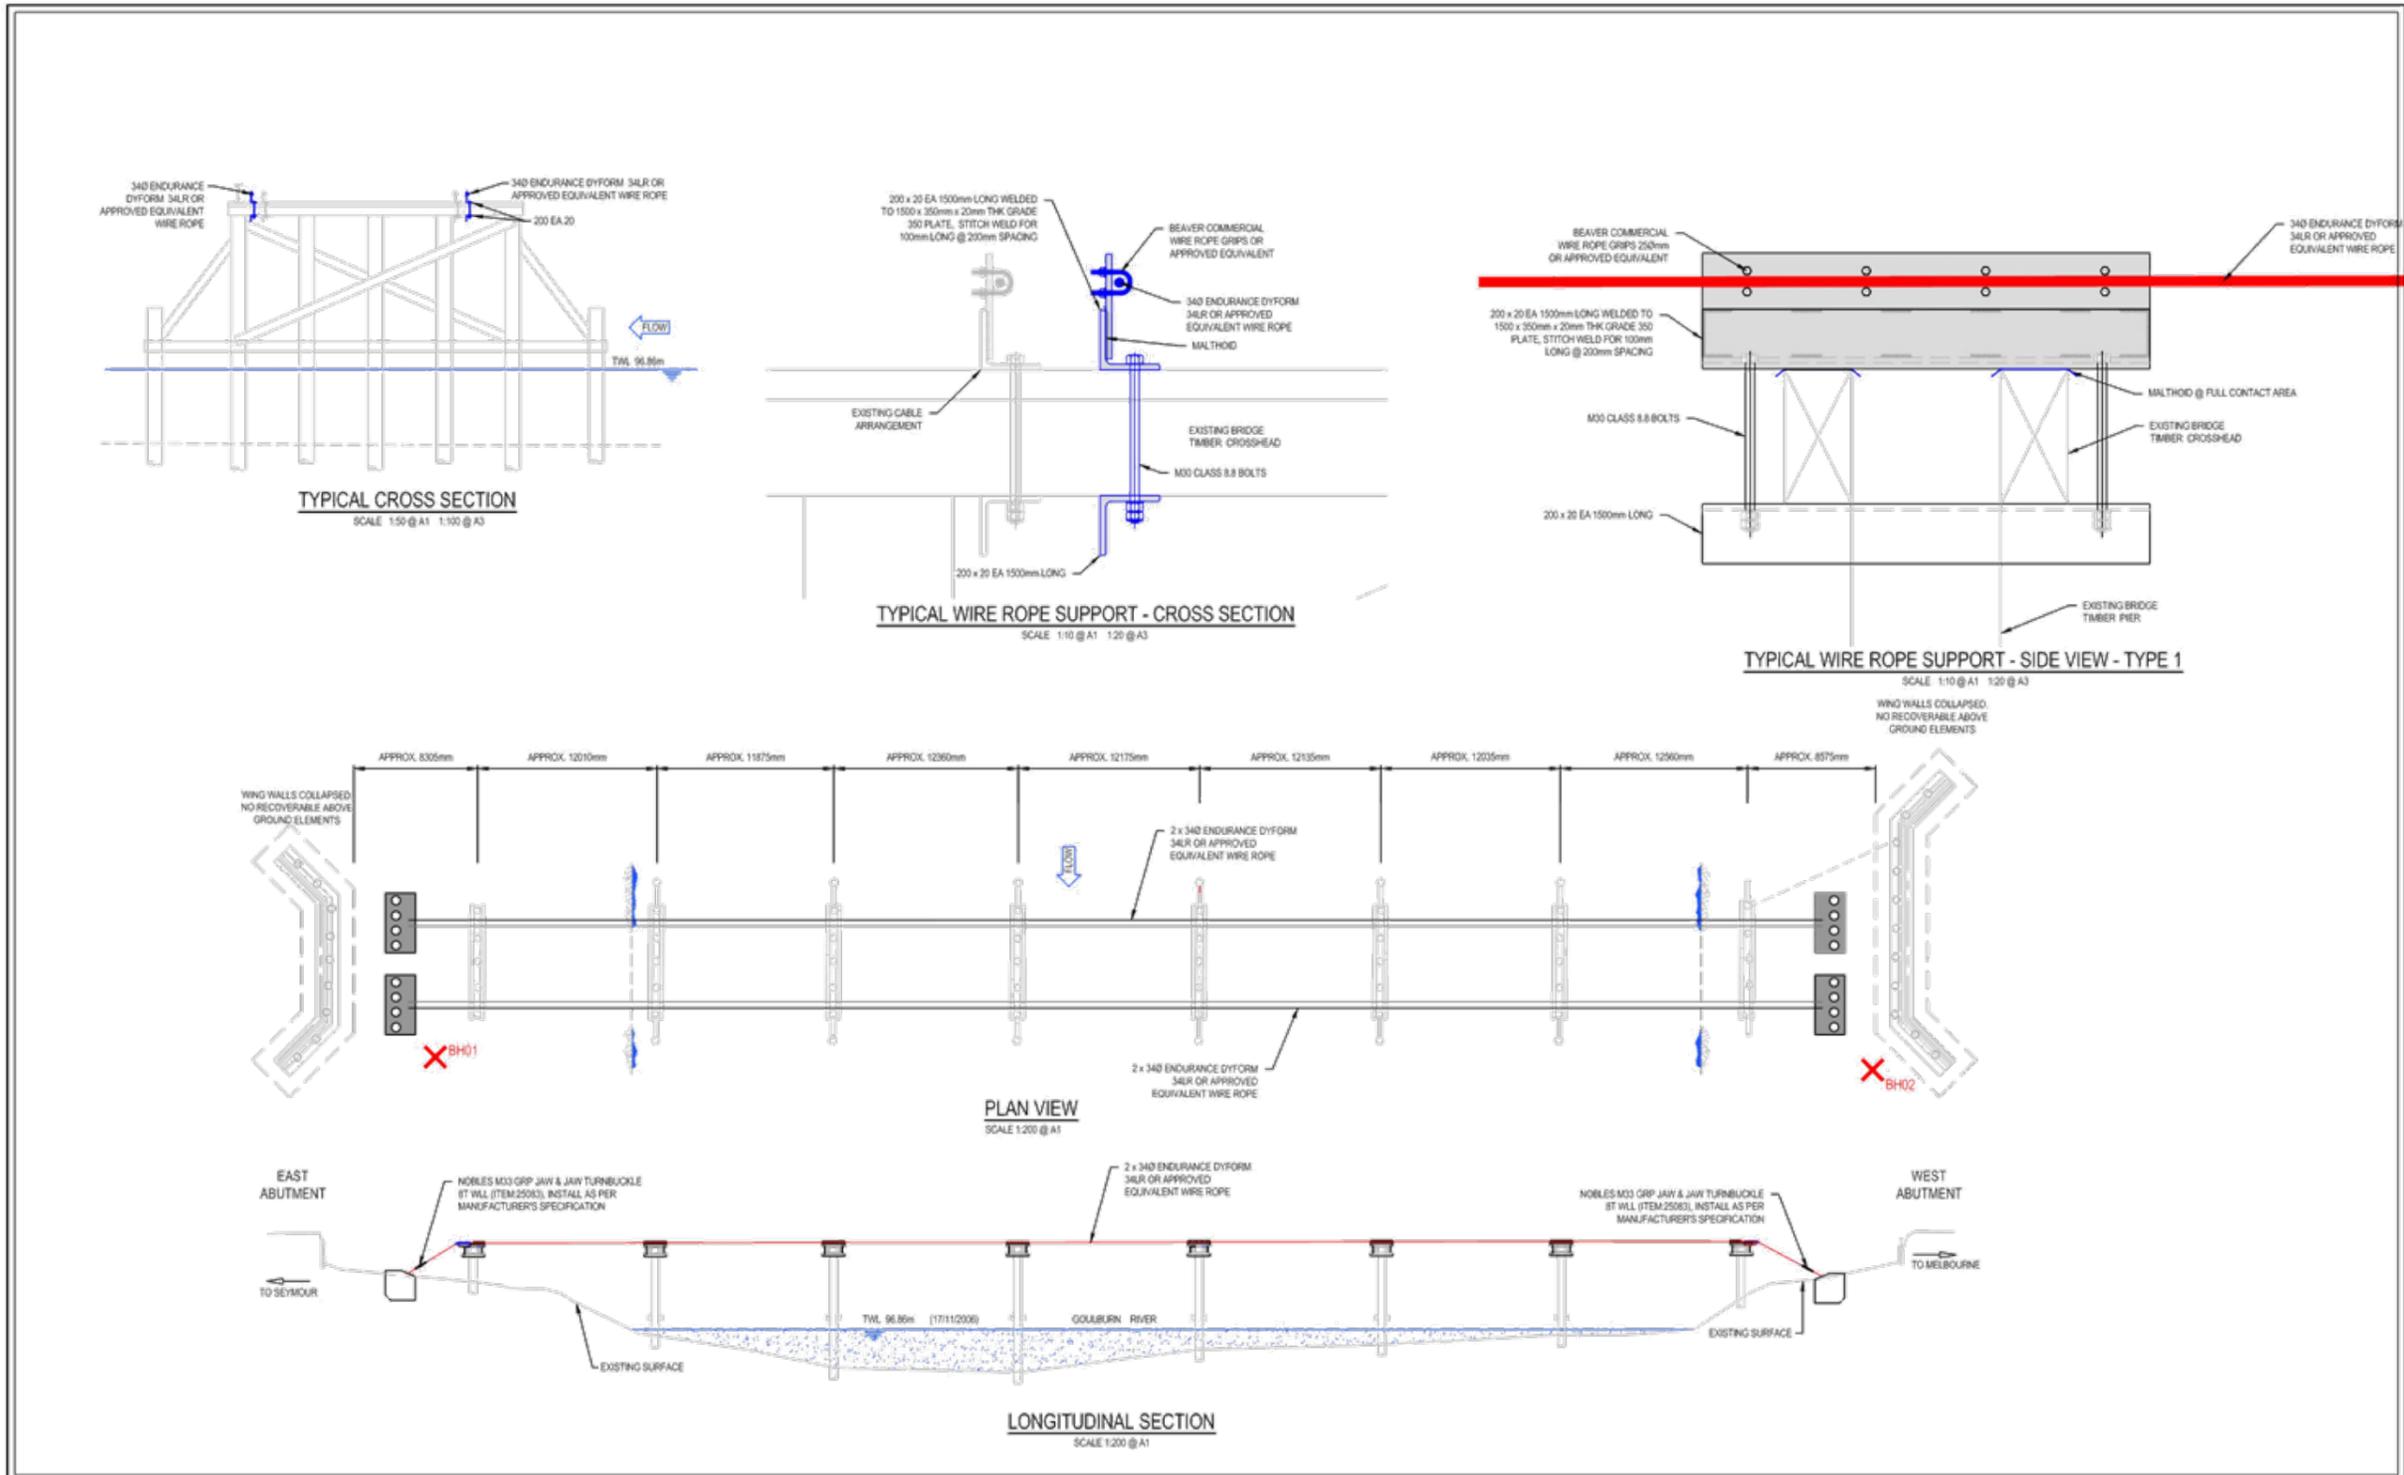
Existing Structure Assessment  
 Drawing No. GMR07048.09.11  
 Revision: A Sheet No. 11  
 GMR07048.09.03 Assessment Report.dwg

11.4 The report concludes that the remaining structure in its current condition, whilst stable, is unable to support the pedestrian loadings of a new bridge structure.

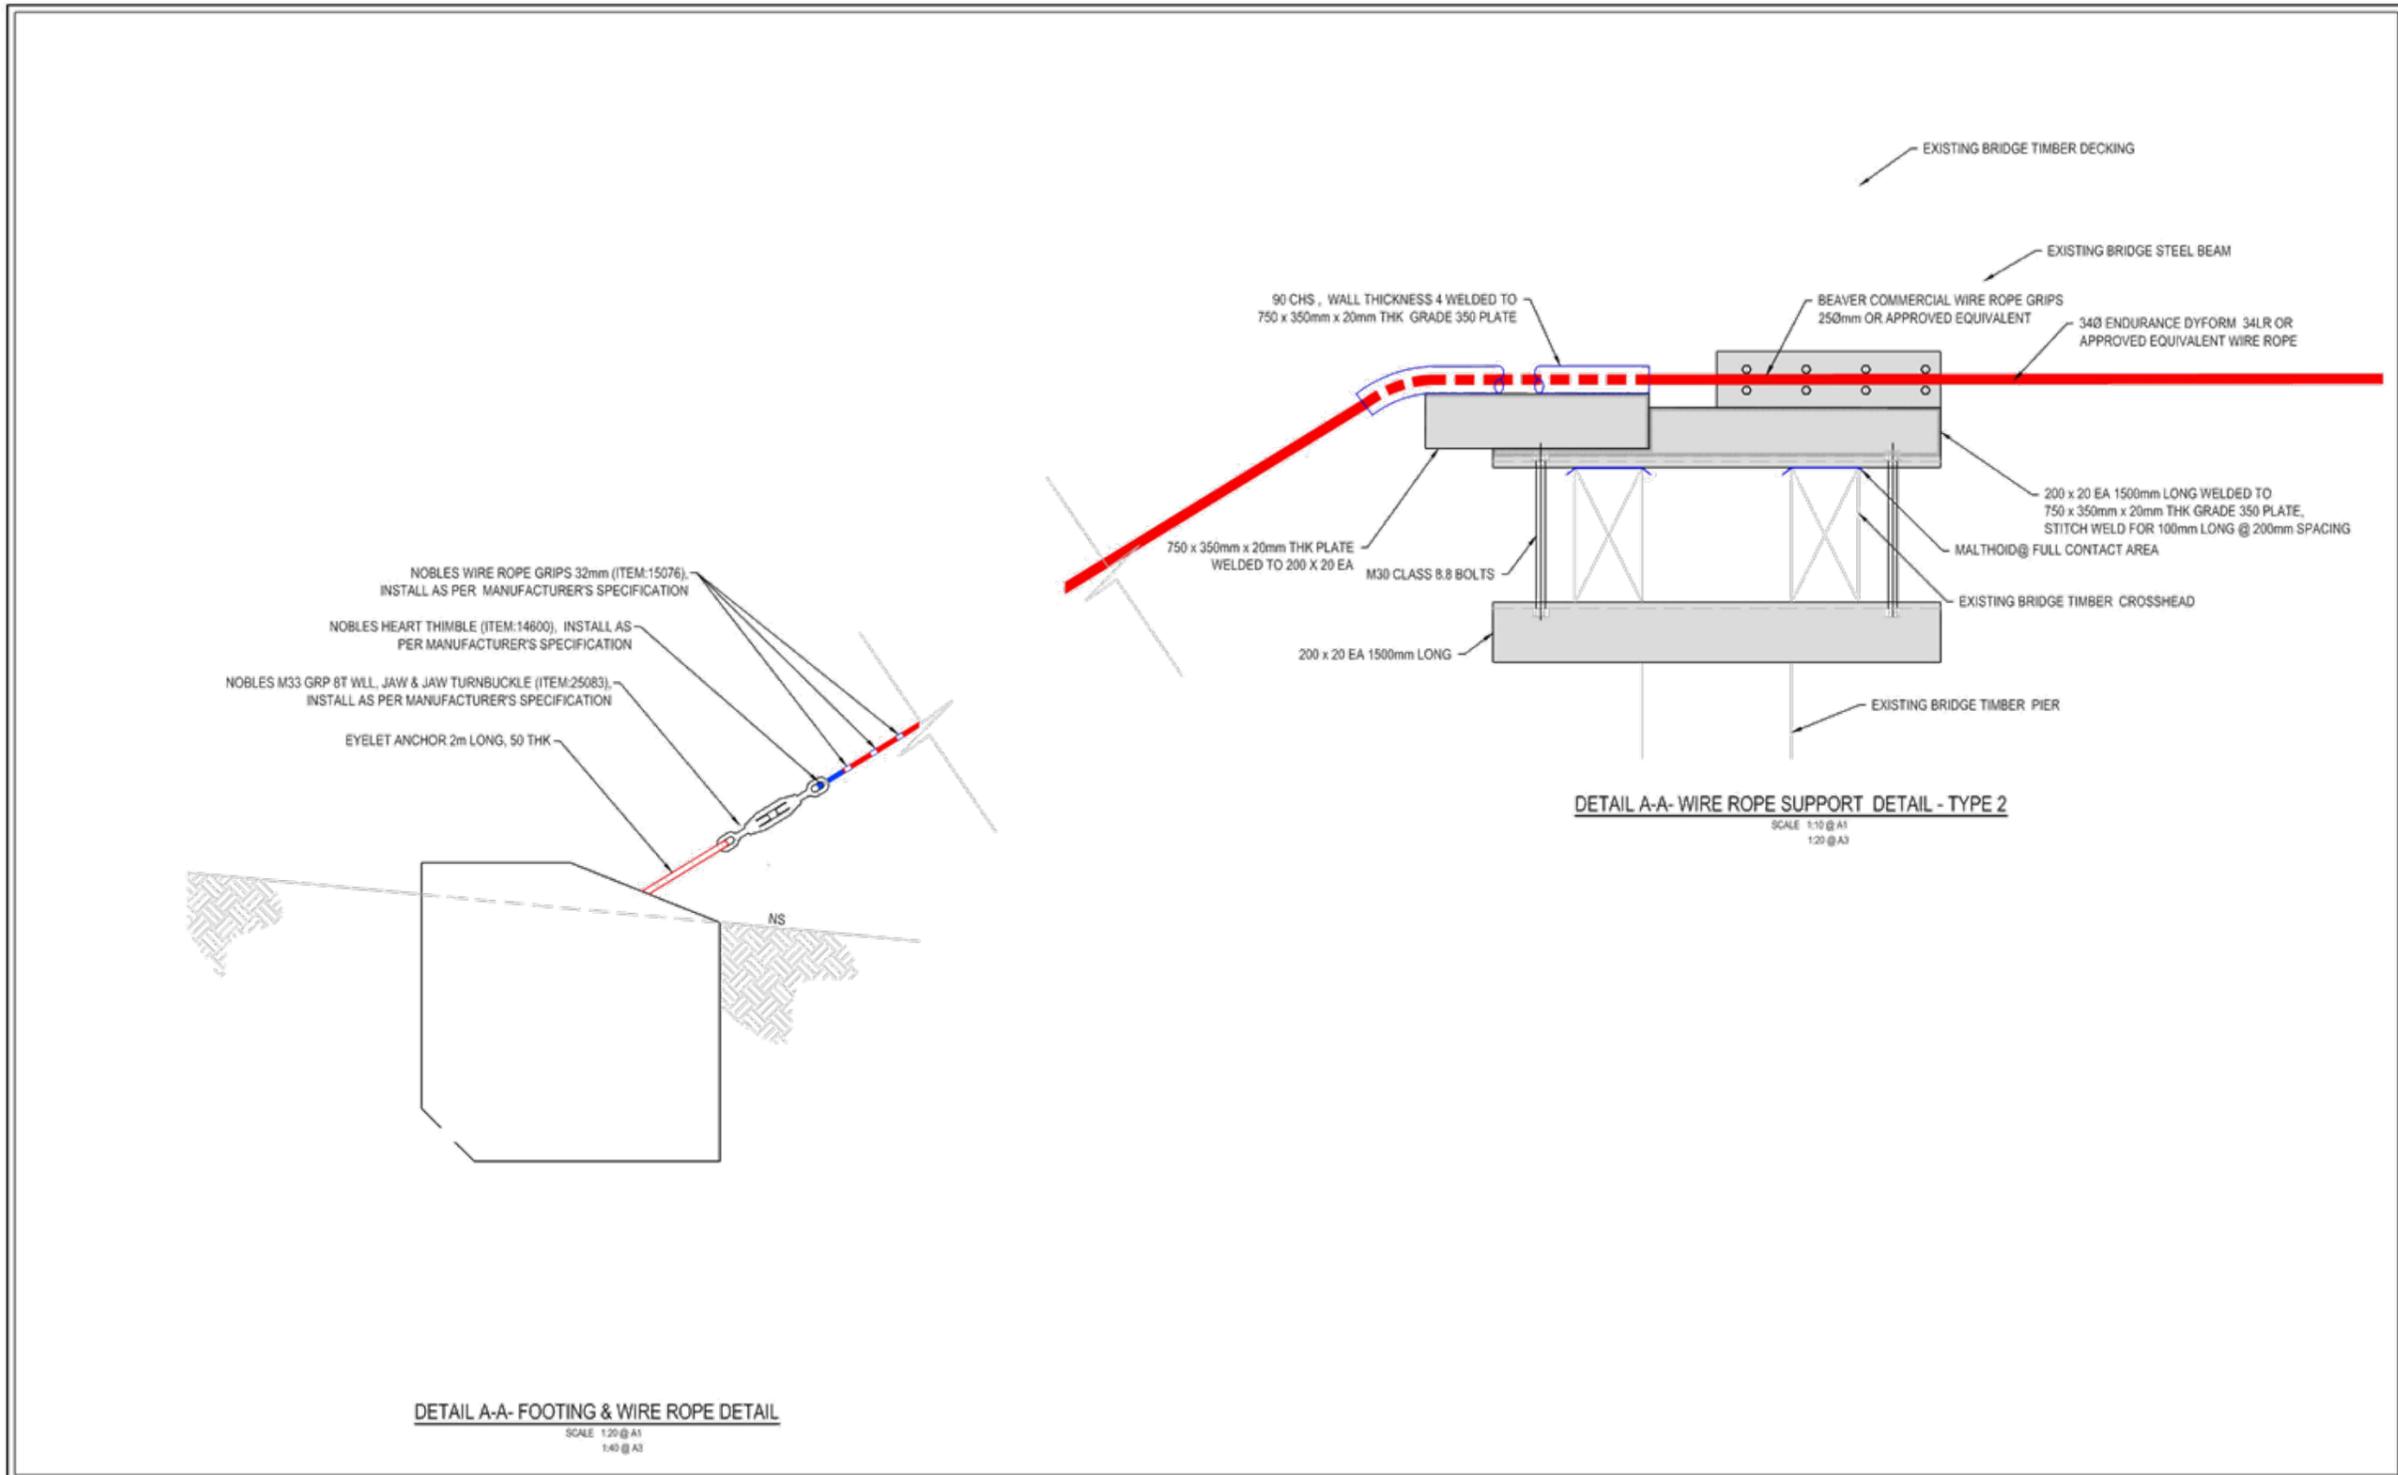
**GMR Engineering Services**  
**Mitchell Shire Council**  
 Seymour Heritage Bridge - Stage 2  
 Goulburn River, Seymour  
 Minimum Repair Works  
 Long-Term Stabilisation of Existing Structure  
 Drawing No. GMR07048.09.12  
 Revision: A Sheet No. 12  
 GMR07048.09.12 Bridge Stability Works.dwg A1

11.2 Section 7.4 of the Structural Assessment report outlines the minimum repair work required for the long-term stabilisation of the remaining existing bridge structure and to satisfy the prerequisites for future reuse as a pedestrian structure.

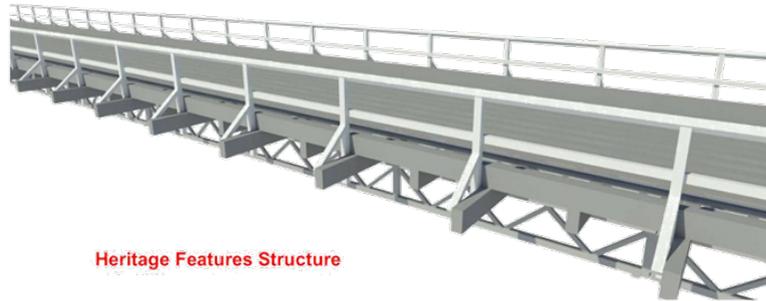
Heritage Features Structure

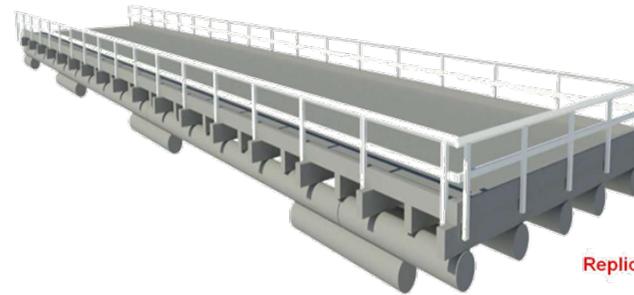
Replica Structure 1

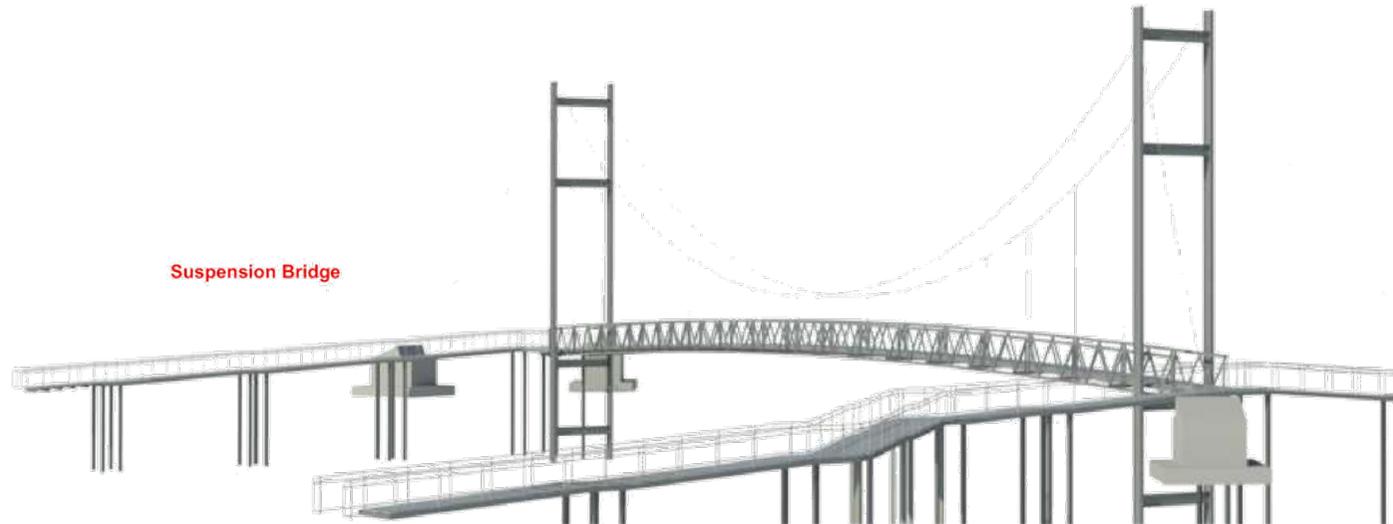
Suspension Bridge
